Conservation of Weathered Sandstone Inscription on the Historic Water Well at Muhammeden Anglo-oriental College, Aligarh

Department of Museology, Aligarh Muslim University, Aligarh, Uttar Pradesh, India

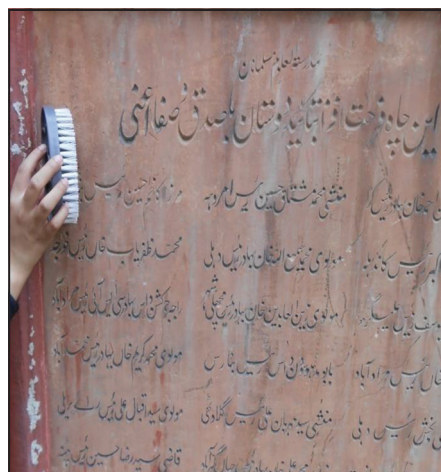
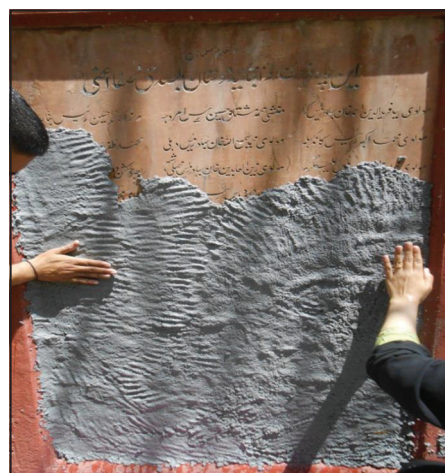
Figure 4: The removal of dust and dried salts with the help of nylon brush and applying of wet paper pulp on the object for the capillary suction.

Figure 5: The removal of dust and dried salts with the help of nylon brush and applying of wet paper pulp on the object for the capillary suction.

First, the removal or desalination of dust and dried salts was carried out. It is most often first step for the prevention of further deterioration in stone. Then, the loosely deposits of salts on the object surface were removed with the help nylon brush, as shown in Figure 4. For the removal of soluble salts from the object, the capillary suction was done with the help of wet paper pulp method, as shown in Figure 5. The forced extraction of saline solution from the interior of the sandstone to its surface may be effectively performed through application of reduced pressure or suction force. The wet paper pulp method helps to compresses after the application over, object was allowed to dry in a natural way, as shown in Figure 6. In the process of drying, salts are pushed out of capillaries and absorbed by the paper pulp. Later, the dry paper pulp was removed, washed, and reapplied on the object. This process was repeated till all the salts were removed from the object.

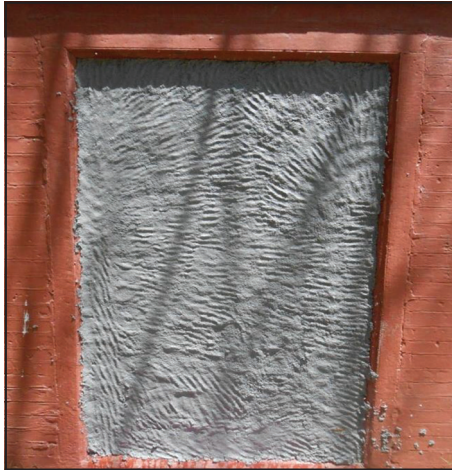
Figure 6: The paper pulp is left for drying in natural light.

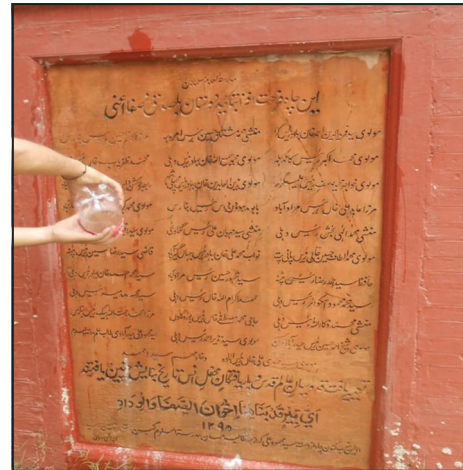
Figure 9: The washing of chemical with water and later the blotting sheet is used to absorb moisture from the object.

to allow the chemical loose the deposit from the surface of the object then it was brushed nicely and the process is repeated, as shown in Figure 8. Later, the whole object was washed and cleaned with running water, as shown in Figure 9. Excess water on object was absorbed with

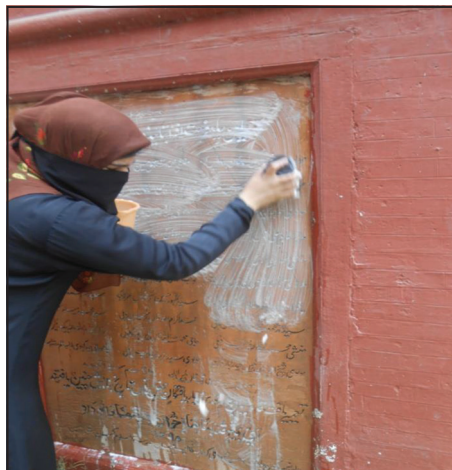
Figure 7: Treating of the object with the chemical solvent and repeated the process of treating through chemical solvent with the aid of brush.

In this process, first, we have prepared the chemical solvent for chemical cleaning of the object. For that, distilled water was taken six parts, with liquor ammonia two parts and liquid detergent two parts equally. Then, the solution was stirred until it was completely dissolved. The chemical solvent was applied on specific area with the help of brush, as shown in Figure 7. It was left for a considerable time

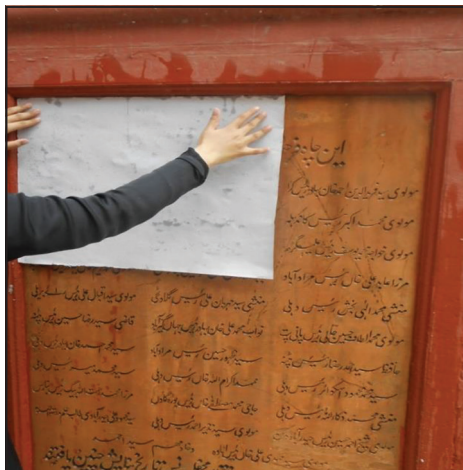
Figure 10: The washing of chemical with water and later the blotting sheet is used to absorb moisture from the object.

the help of blotting sheet by applying on the wet area of object, which is also shown in Figure 10. At last, it is exposed in sunlight entire a day for the complete dehydration of the object, shown in Figure 11.

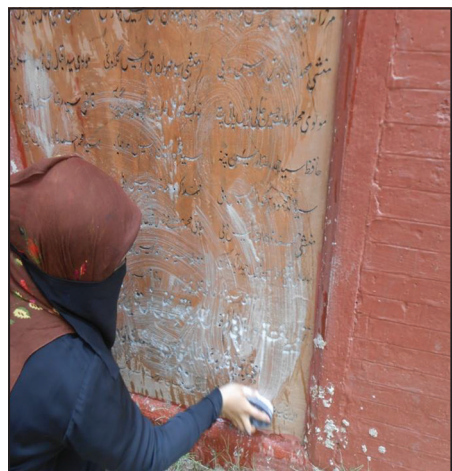
Figure 8: Treating of the object with the chemical solvent and repeated the process of treating through chemical solvent with the aid of brush.

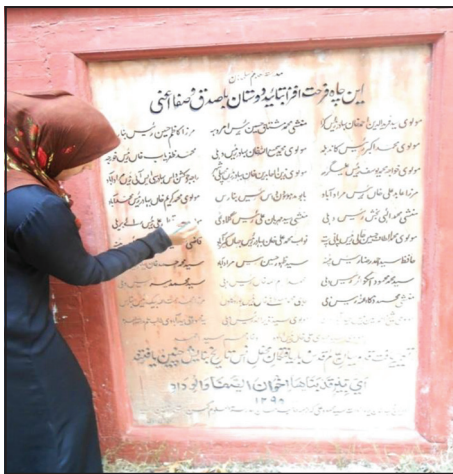
Figure 12: The exposure of sunlight for the entire day to complete dehydrate the object and later demonstrated the process of refilling of black ink in lose part of sandstone inscription (text carved) on water well.

Finally, restoration of the lose ink from the sandstone inscription on water well is done. It is refilled with the help of black oil paint, as shown in Figure 12.
